## CENTRAL INTELLIGENCE AGENCY

SUBJECT Soviet Airfield near Bad Vöslau

Sketch of Military Airfield  
near Bad Voslau

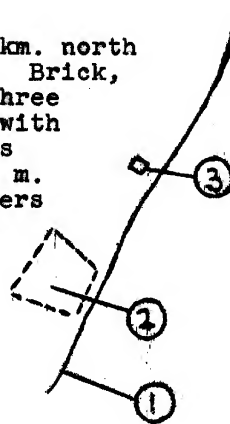
Location of Military Airfield near Bad Voslau

1. Road - 6 - 7 m wide, paved, one of the principal roads in the area. The road led north to Vienna.

2. Military Airfield

3. Small Building - Located approximately 2 km. north of the airfield, 200 m. west of the road. Brick, single storied, gable roof. There were three metal masts in the vicinity of the house with wires strung between them (number of wires unknown). The masts appeared to be 12-15 m. high. Occasionally

soldiers (1-2) in the area of the building. Their uniforms were not identified.

there was some sort of connection between this building and the airfield.

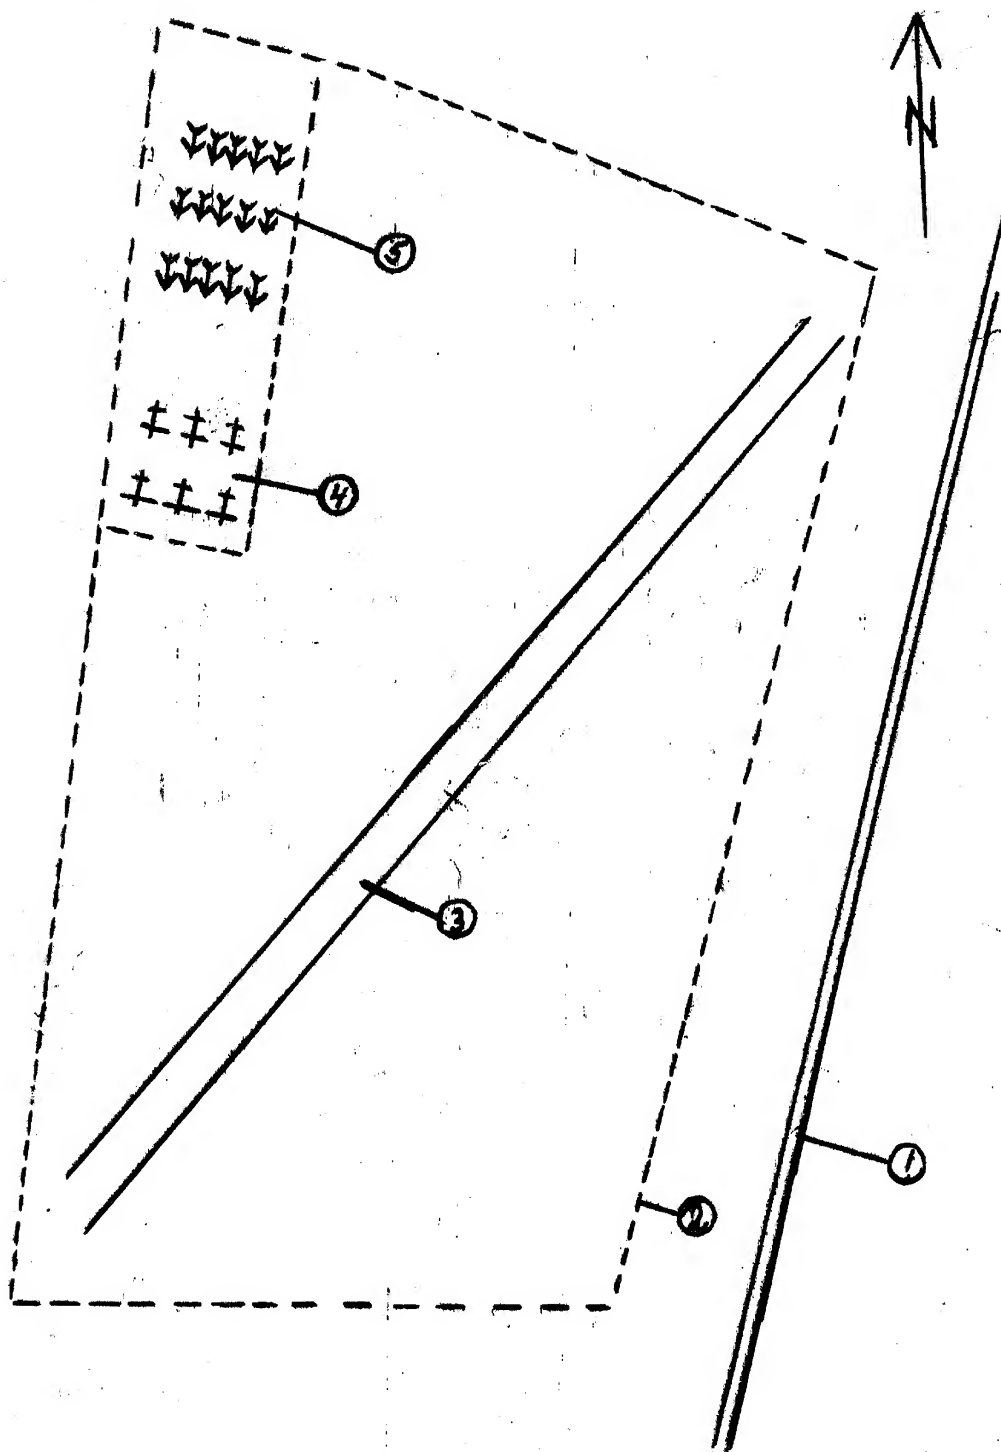
Legend to [ ] sketch of the military airfield near  
Bad Voslau (N 47-58, E 16-13) [ ]

1. Road - Same as Point 1, on overlay (see page 3 ).
2. Airfield Boundary - Indicated by broken line. [ ]  
[ ] there were no fences or any  
visible boundary markers enclosing the airfield area. The  
field was grass surfaced. 25X1  
25X1

3. Runway - Length unknown, surface unknown. The northernmost  
section of the runway was located approximately 300 meters  
from the road [ ] at  
night [ ] no [ ] runway lights or other field  
lighting. 25X1  
25X1

4. Aircraft Parking Area - Surface and dimensions unknown. It  
was located approximately one kilometer from the road. [ ] 25X1  
[ ] only twin engine conventional aircraft, types not  
identified. [ ] there might have been some  
four-engine aircraft in the area but, because of the distance from  
which his observation was made, he was reluctant to make a  
positive statement. The aircraft were lined up in rows, and  
facing to the south. The exact number of twin-engine planes  
in this area could not be estimated, but the number appeared  
to be less than the number located in the aircraft parking area  
(Point 5 below). The aircraft were silvery. No aircraft  
insignia [ ] were noticed. 25X1  
25X1  
25X1

5. Aircraft Parking Area - Surface and dimensions unknown. [ ] 25X1  
[ ] three rows of jet fighter aircraft parked here. [ ] 25X1  
positively identified [ ] as MIG-15's. There were four or five  
jets in each row. The aircraft were facing south. The air-  
craft were silvery. No aircraft insignia [ ] were  
noticed. 25X1

1. The military airfield near Bad Vöslau was not visibly guarded, (for pinpoint location see page 5; for [redacted] sketch and details, see pages 3 and 5.) [redacted] there were guards in the vicinity of the parking areas. To the north of the airfield the terrain was flat. [redacted] Beyond the aircraft parking areas to the west [redacted] several buildings. [redacted] 25X1
